An Ultramodern Building Shows Signs of Age

By CATESBY LEIGH

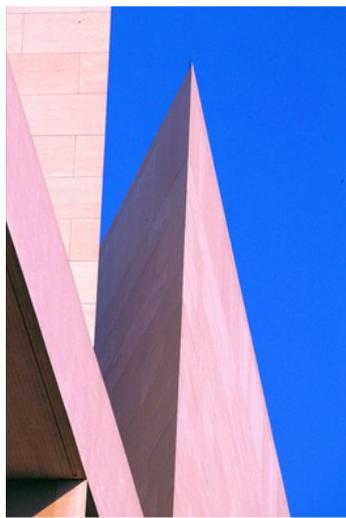
A detail of the marble paneling.

Pei's panels hang two inches out from the brick infill within the East Building's load-bearing concrete frame. (The two-inch air gap helps prevent moisture from getting inside the building.) The bottom corners of adjacent panels rest on stainless-steel, J-shaped "gravity clips" that are 8 inches wide and fitted into slots in the bottom of each panel. "Lateral anchors," stainless-steel pegs whose hooked ends are fitted into holes on top of the panels, hold them in. Contrary to appearances, these marble panels are not intended to bear the weight of the stone above. The gravity clips and lateral anchors transfer that load back to the frame.

The standard minimum joint width for curtain-wall stone cladding is a quarter-inch, but for the sake of uniformity Mr. Pei retained Pope's narrow, 1/8-inch joints. (He noted during the 1993 interview that such fine joints were "very rare.") Instead of the caulking materials usually employed with stone cladding, Mr. Pei opted for soft, tubular gaskets made of neoprene, a synthetic rubber. The flexible gaskets would allow the marble panels to expand in hot weather and contract in the cold while "floating" on their stainless-steel supports. The gaskets also would spare the East Building the need for wide, visually disruptive expansion joints—a standard feature of curtain wall veneer, running horizontally and vertically at regular intervals to accommodate thermal movement. And while caulk can deteriorate after just a few years, the East Building gaskets were supposed to provide a weatherproof seal for half a century or more.
